Case Study:
**Corrosion of the Alewife MBTA Parking
Garage**

Amanda P. Siciliano

ENMA 664: Environmental Effects on Engineering Materials

18 December 2021

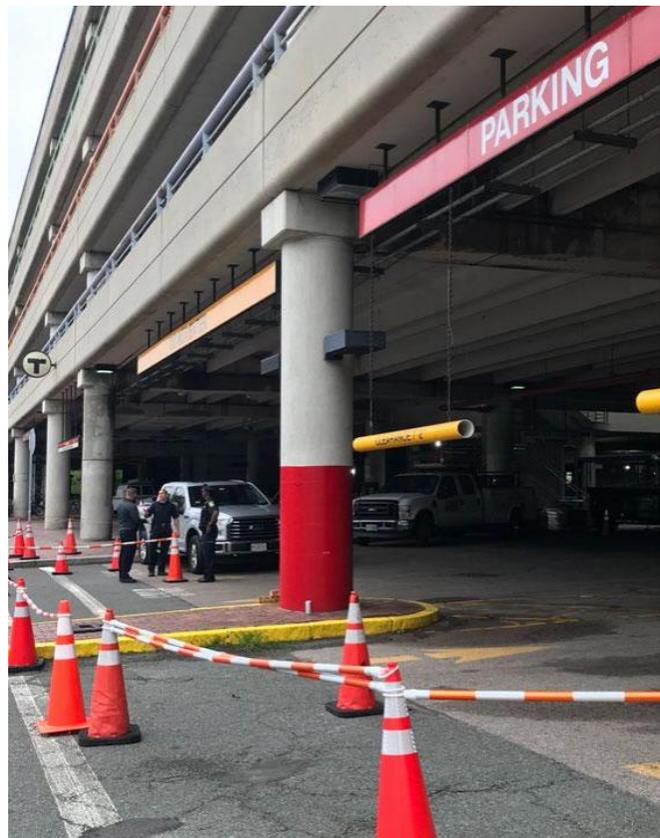
Most of the corrosion in the Alewife MBTA Parking Garage is visible in the deteriorated concrete beams and decks along with the exposed steel reinforcing bars, which are also known as rebar [9]. Though this project was granted a \$14 million project, as shown in progress in *Figure 3*, in 2021 and has had over \$20 million in rehabilitation projects in the past 10 years, the Alewife MBTA Parking Garage is a perfect example of the types of corrosion projects that are so prevalent and costly throughout the United States [7]. In

Figure 3: Image of Ongoing Construction and Rehabilitation Project Repairs at Alewife MBTA Parking Garage Station Complex [7]

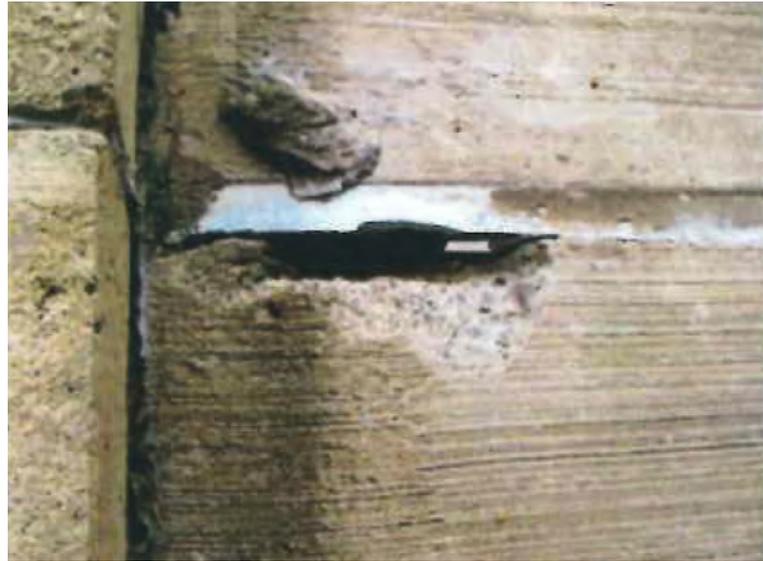
The main sources of deterioration in this case study project can primarily be attributed to three different sources: water infiltration, cold climate and bird nesting. For the Alewife MBTA Parking Garage, broken and clogged drainage pipes often cause concrete spalling and cracking [2, 3]. The sealant and spalling

Figure 4: Image of Flange Joint Deterioration at Alewife MBTA Parking Garage Station Complex [3]

failures permit water to seep through and cause deterioration to metal decking. This concrete and decking erosion is exacerbated by broken and clogged drainage, where pooling and ponding can accelerate structural deterioration. It is worth noting that the lower levels of the parking garage experience the highest levels of corrosion, as beam and joint cracks, as shown in **Figure 4**, allow water to leak and infiltrate to lower levels of the garage especially in comparison with corrosion levels in upper roof levels [2, 3]. Though this water can come directly from natural sources like rain or ice, this water can also come from indirect sources such as car tires, vehicles and other contaminated runoff. In addition to corroding the concrete decking and metal rebar of the Alewife MBTA Parking Garage, the water infiltration can have harsh environmental effects on the nearby Little River and Alewife Brook from contaminated runoff [4].

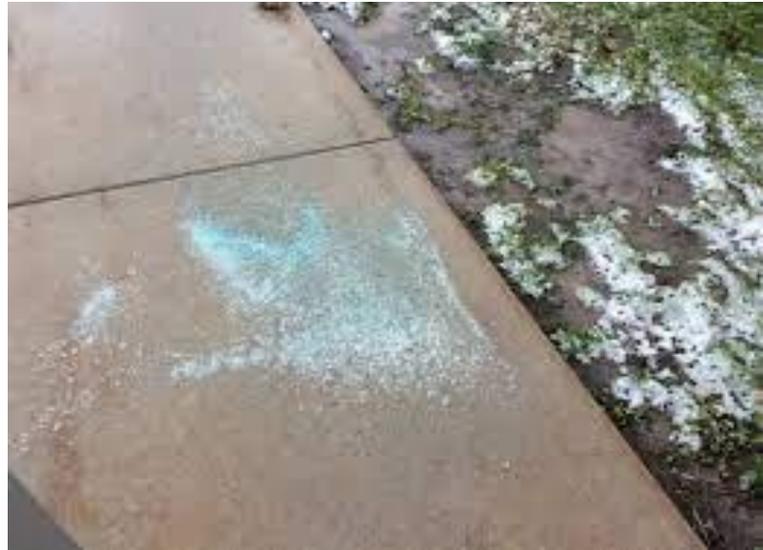
The garage is located in the Northeast where environmental temperatures frequently range from about 90 to 10 °F [12]. Throughout the Boston and Cambridge areas, deicing salts, as shown in *Figure 5*, are often used during the winter to combat ice and snow conditions [13]. Typically, deicing salts and chemicals are carried into parking

Figure 5: Image of Deicing Salts on Concrete Typically Used in Northeastern US Locations [13]

garages through the tires of different vehicles. These salts, which tend to have high chloride ion content, speed up corrosion in reinforcing steel and concrete decking via failed sealants and broken joints. Another component of the cold winter climate includes freeze-thaw degradation, as constant successive cycles of varying temperatures can create expansion and contraction in concrete.

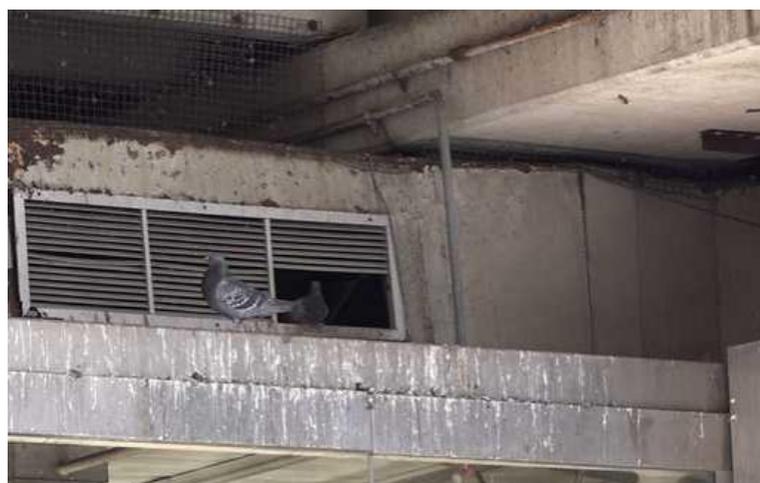
An additional source of degradation experienced by the Alewife MBTA Parking Garage relates to pigeons and the creation of nests in precast birders along the perimeter of the structure, as shown in *Figure 6* [2, 9, 14]. These birds, which often create their nests in

Figure 6: Image of Pigeons Nesting in HVAC Systems Along Perimeter of Alewife MBTA Parking Garage Station Complex [9]

HVAC systems and throughout the shelves of girder ledges, accelerate structural deterioration of the garage [3]. In fact, bird droppings tend to be highly acidic in nature, so accumulated droppings throughout the parking garage accelerate deterioration of concrete and reinforcing steel over time.

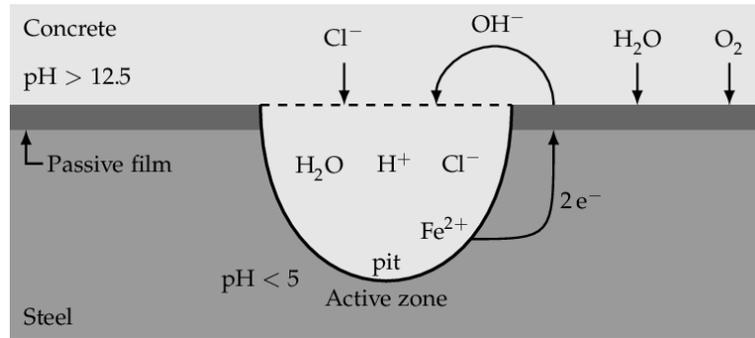
The main corrosion mechanism located in the Alewife MBTA Parking Garage falls within the pitting category. This corrosion mechanism tends to be a very highly localized type of attack due to the failure of the

Figure 7: Image of Pitting, the Predominant Corrosion Mechanism, at Alewife MBTA Parking Garage Station Complex [16]

passive film layer, which results in very high-speed penetration in smaller areas [15]. This type of corrosion mechanism can be one of the hardest to control, as it is incredibly uncertain in terms of the location and rate at which it will occur. As a result, there can be an entire parking garage floor with varying levels of corrosion [2]. Surface discontinuities, such as scratches, wears, and debris, can commence pitting corrosion by serving as an initiation location. Within this specific case study, high chloride ion content, which is usually carried in from deicing salts washing off of vehicles, attacks the passive film of concrete flooring and metal rebar, as shown in **Image 7** [16]. The anodic reaction occurs within the steel rebar, and has a chemical equation as follows:

As a result of these reactions, pits form and grow. A loss of material occurs, which first penetrates the protective passive film and eventually leads to defects within the concrete decking and steel rebar [15]. Typically, different corrosion detection methods will be used to examine and evaluate altering levels of deterioration while several different corrosion prevention techniques will be employed to ensure no further degradation and structural failure occurs within the project.

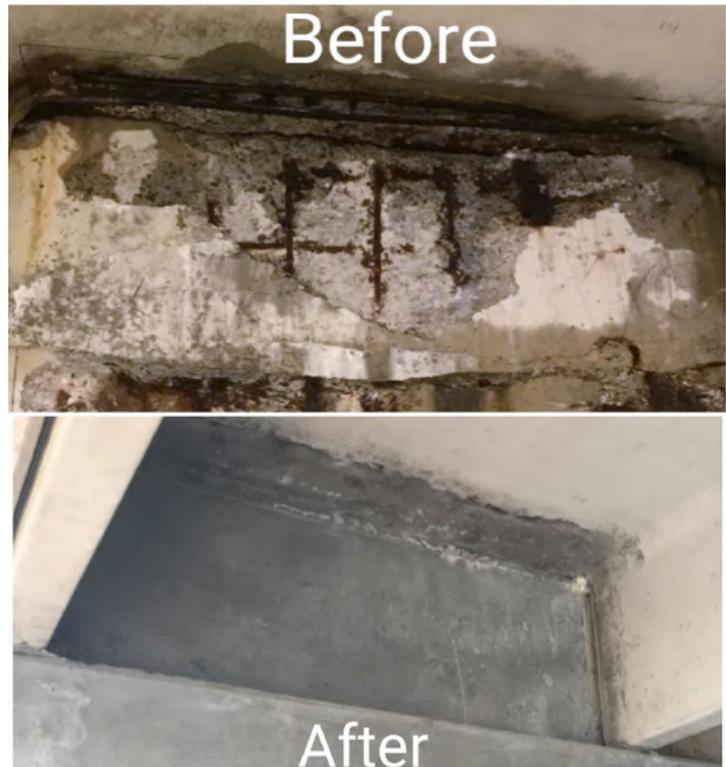
Figure 9: Image of Precast Beams Before and After Repairs at Alewife MBTA Parking Garage Station Complex [19]

includes the method of sanding, cutting and cleaning out exposed reinforcing bar rust, as shown in *Figure 9* [19]. This technique enhances the service life and current state of the precast beams, as it removes corroding and rusted

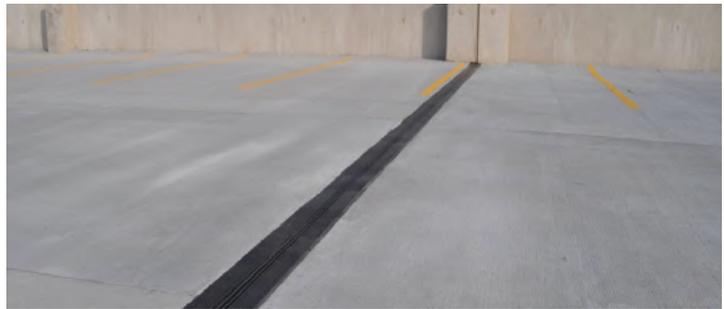
Figure 10: Image of Expansion Joint Covers at Alewife MBTA Parking Garage Station Complex [20]

components. The second suggestion includes the method of applying an epoxy bonding agent coating or rust inhibitor paint. It is worth noting that this technique was the most popular suggestion for this project, as corrosion-prevention coatings tends to be a cheaper and more time-effective alternative for replacing specific structural components. Additionally, this method is superior when understanding that corrosion can happen in localized and uneven rates. The third suggestion includes the method of cleaning and fully replacing joint covers, as shown in *Figure 10* [20]. This technique protects joints, which are some of the most susceptible locations in concrete decks and prevents further deterioration from occurring. It is worth noting that throughout the project, many of the joint covers were found to be either fully corroded or

completely missing. Thus, this technique was the second most popular suggestion for preventing corrosion throughout the project.
