Case Study:
**Corrosion of the Alewife MBTA Parking
Garage**

Amanda P. Siciliano

ENMA 664: Environmental Effects on Engineering Materials

18 December 2021

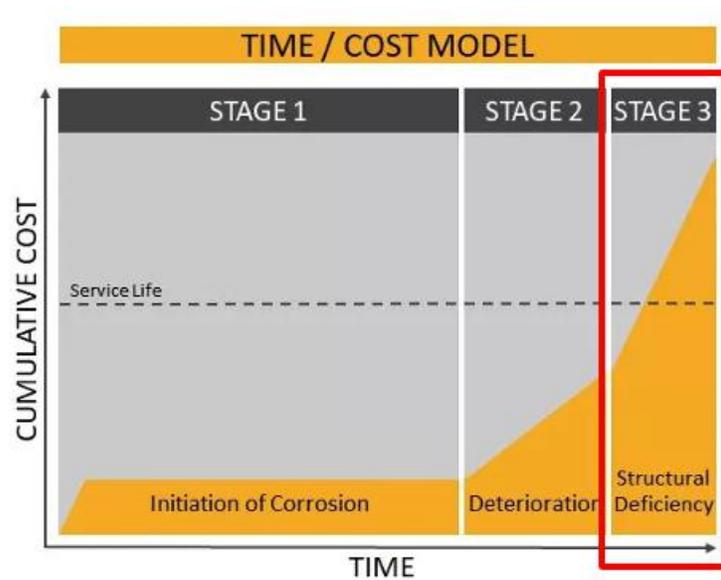
Figure 8: Image of Corrosion Time vs. Cost Model to Describe the Kinetics of the Corrosion Mechanism at Alewife MBTA Parking Garage Station Complex [17]

that this project is predominantly experiencing a logarithmic oxidation rate, as shown in **Figure 8** [15, 17]. Upon experiencing initial levels of corrosion and accepted levels of deterioration, the Alewife MBTA Parking Garage was experiencing linear oxidation. However, the conditions

state in the aforementioned 2011 and 2017 engineering condition assessment reports indicated a different type of oxidation [2, 3]. The levels of corrosion included within these reports are indicative of a logarithmic oxidation rate, which is typically applied for thin, protective films at low temperatures [15]. In this model, the logarithmic oxidation rate has an equation as follows:
